BEAUMONT INSPECTIONS, LLC. WESTERN NORTH CAROLINA

RESIDENTIAL REPORT

John Beaumont

Certified InterNACHI Home Inspector, Licensed in
North Carolina

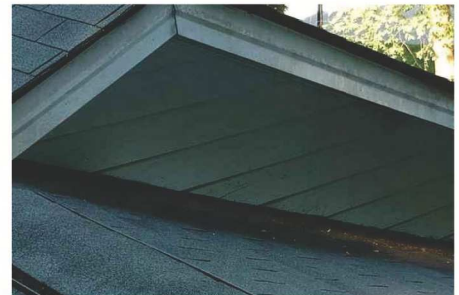
UPPER LEVEL EXTERIOR WALL RIGHT SIDE

Step wall flashing is not visible. Exterior wall finishes are too close to roof finish to allow observation. This is a defect. Storm water running down slope can migrate through the exposed cut edges of the finish siding. Prolonged exposure to moisture creates the ideal condition for wood rot.

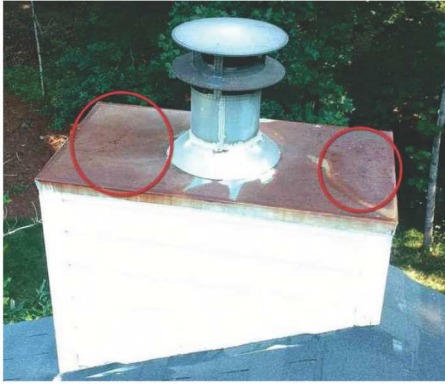
2.1.1 Chimney

CHIMNEY CAP RUST

The galvanized metal chimney cap shows evidence of rust and/or ponding of rain water. Recommend monitoring the chimney cap which may have to be replaced at some point.

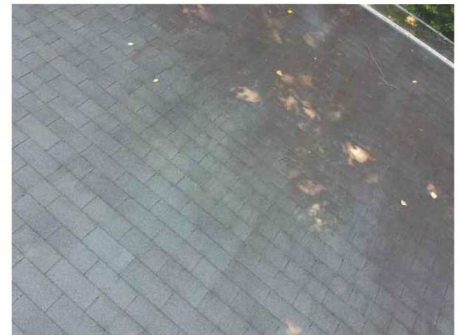
Right Side of Roof At Rear

DISCOLORATION

Roof shingles were discolored, which can be caused by moisture, rust or soot. Recommend a qualified roofing contractor evaluate and remedy with a roof cleaning or repair.

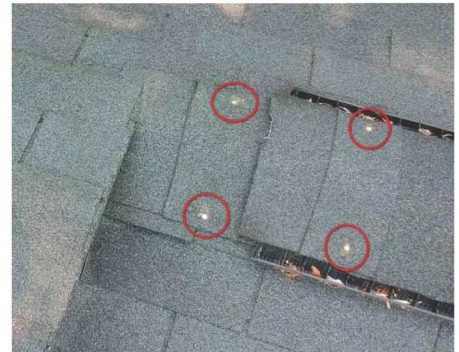
There are exposed nails on the ridge cap. Recommend roofing sealant as soon as possible to prevent water damage.

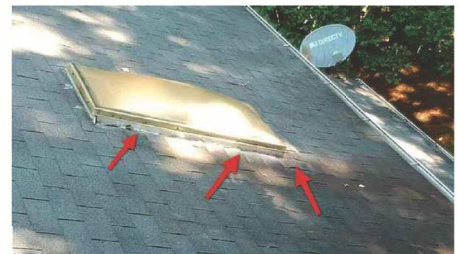
Shingles At Skylight

ROOF SHINGLES CURLING

The roof shingles adjacent to the skylight are showing signs of wear. The shingles along the perimeter of the skylight are beginning to curl. This condition can create a penetration point for wind driven moisture to enter the attic and damage roof framing. Recommend a qualified roofing contractor evaluate.

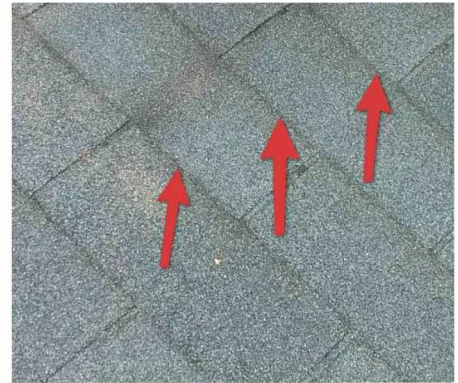
The age of the roof is showing on the edges of the roof shingles. The deterioration of the shingle will become apparent at the edges first. As the shingles age, the Asphalt used to attach the colored granules to the shingle begins to become hardened causing the granules to dislodge. The edges of the shingles are susceptible to higher fluctuations of temperature and more aggressive wear from wind, water, and snow. Recommend monitoring of the roof by qualified roofing contractor.

Recommend monitoring.

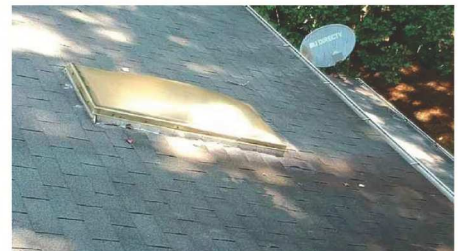
The skylight has discolored and clouded. The plastic exterior surface of the skylight has been sun damaged and is no longer transparent. Recommend replacement by a qualified roofing contractor.

Contact a qualified roofing professional.

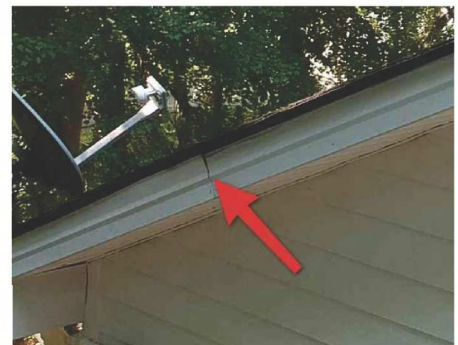
Left Side Elevation At Sunroom

FLASHING INSTALLED INCORRECTLY

Flashing is installed with an open end facing up the roof rake. It has opened a gap and is a potential source of water intrusion to the fascia. Any water entering this location can run insit the flashing to the eave of the house and cause moisture issues. Recommend replacement of the flashing

Contact a qualified carpenter.

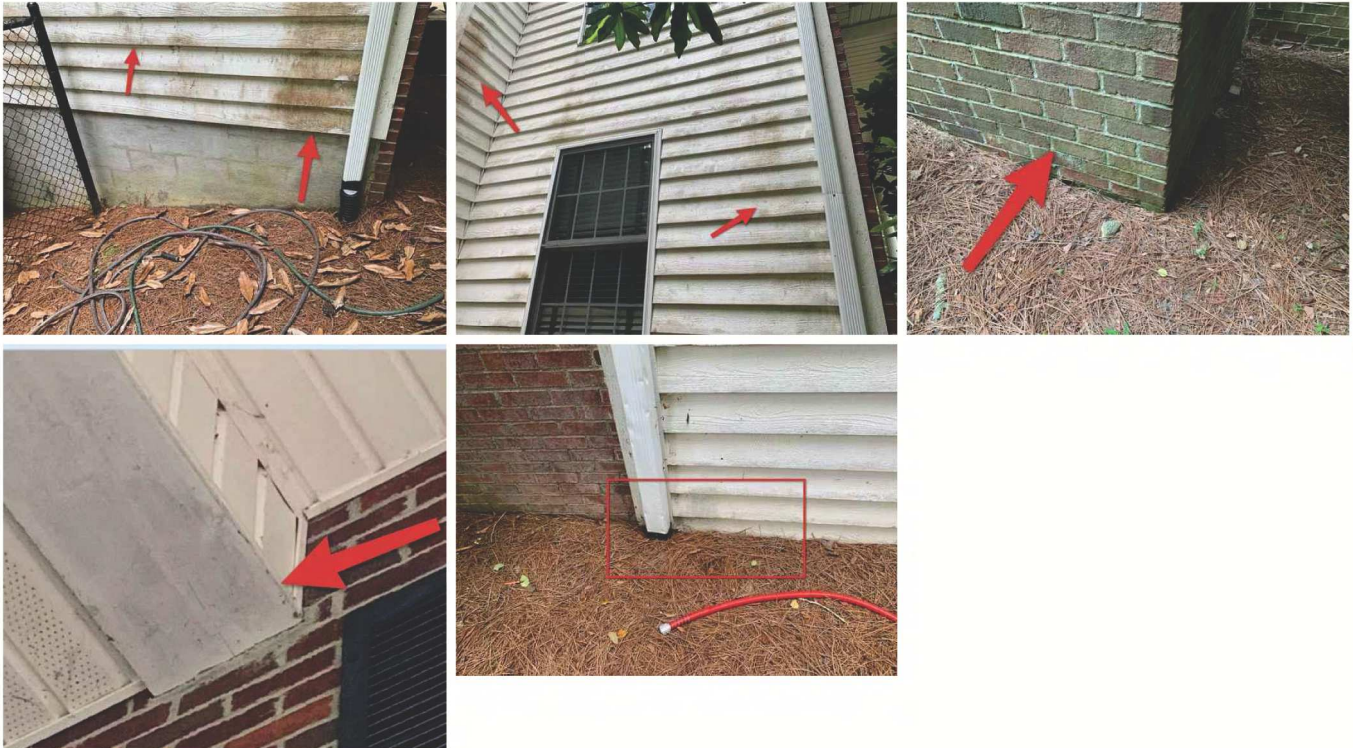
There are signs of algae and/or mildew on the siding. This is a cosmetic issue and is not uncommon especially on shaded portions of the home. Recommend that said areas be washed or cleaned on a regular basis.

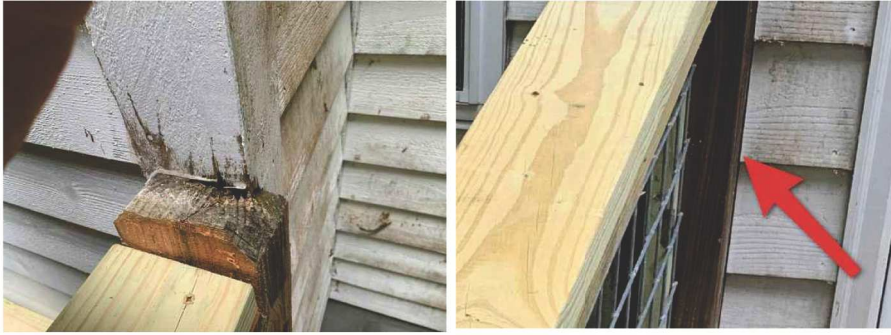
DECK POST NOT FLASHED TO SIDING

The exterior deck handrail posts are cut into the exterior siding of the home. No flashing is visible. Signs of moisture penetration and saturation of the siding is present. Recommend installation of heavy duty sealant as a temporary stop-gap until it can be properly re-built by a qualified carpentry contractor.

Contact a qualified carpenter.

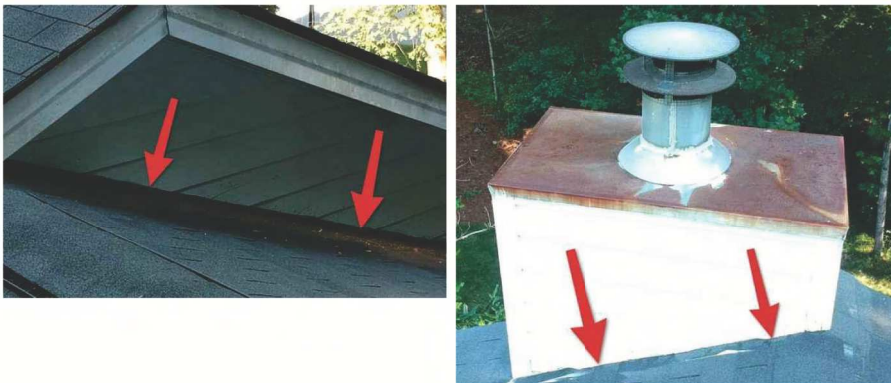
The wood siding is in contact with the roof covering. This condition will trap moisture and rot the ends of the siding. Step flashing is not visible. The siding should have a 1 inch air gap between the cut edge of the siding and the finished roof covering. This allows moisture to drain freely and dry out. Recommend evaluation by a qualified carpentry contractor.

Contact a qualified carpenter.

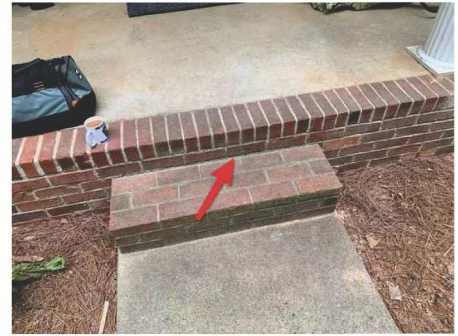
Front Step

A small crack is developing between the Brick step and the front porch. This crack should be sealed to prevent further damage to the step from freeze thaw cycles. Recommend a handyman seal the crack.

Contact a qualified handyman.

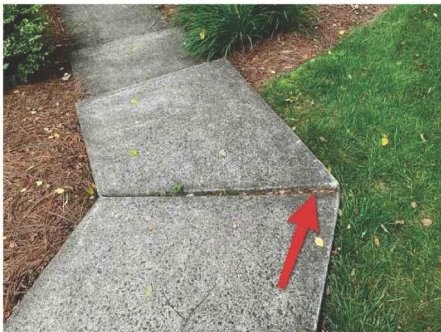
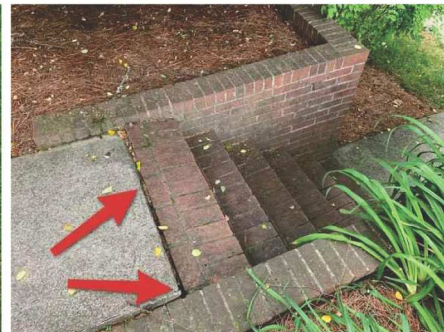
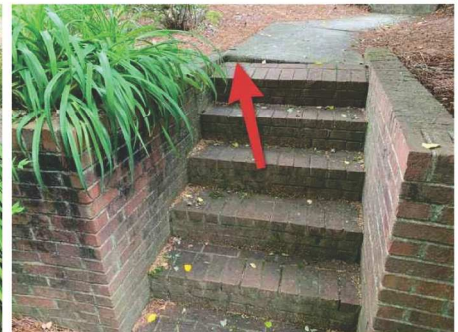
Several sections of the front concrete walkway have settled uneven with each other. This creates trip hazards where the edges protrude above one another in the path of travel. Recommend a qualified concrete contractor further evaluate to determine the best way to level the walkway sections.

Contact a qualified concrete contractor.

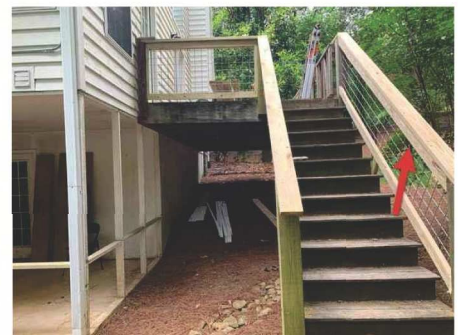
Deck Left Side Elevation Stair

GRASPABLE HANDRAIL MISSING

Exterior deck stair is missing a graspable handrail. This is a safety issue. Recommend a handyman or carpenter install a handrail.

Contact a qualified professional.

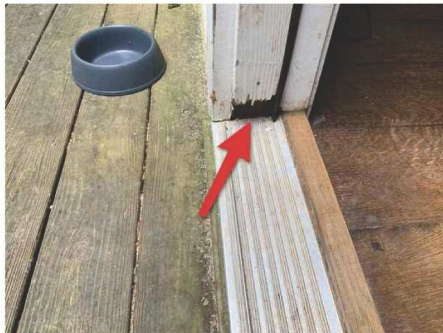
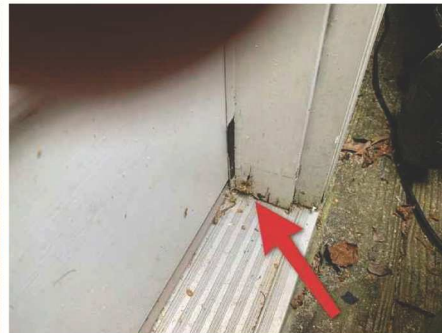
Exterior Door At Dining Room

The Door jamb is rotted at the aluminum sill. Missing portions of trim allow water intrusion into the wall cavity and can cause moisture induced issues in the finished spaces below this area. Recommend repair or replacement by a qualified carpentry contractor.

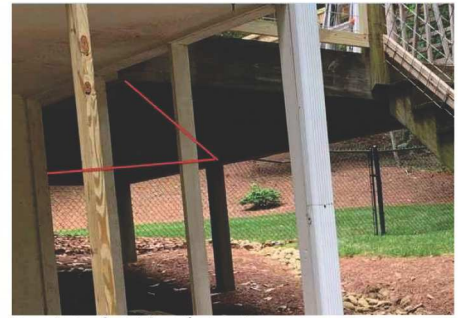
Deck Left Side Elevation

DECK - FLOOR JOIST CROSS BRACES MISSING

Deck floor joists lack diagonal bracing. Cross bracing is run flat against the bottom of the deck floor joists typically at a 45 degree angle with the joists. They start at the ledger board and run diagonally towards the middle of the deck at the furthest rail from the residence. They provide rigidity to the floor system and help prevent sway. Recommend installation of diagonal bracing.

Contact a qualified carpenter.

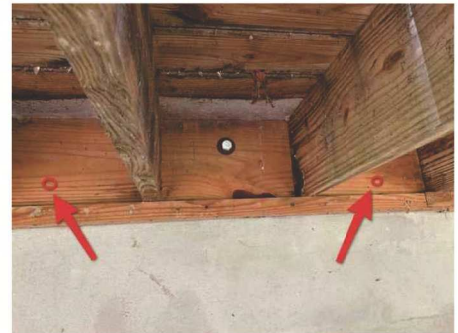
Underside of Deck Left Side Elevation

DECK - LEDGER LAG BOLTS MISSING

Ledger board at house lacks adequate bolting to the structure of the home. Recommend a qualified carpentry contractor evaluate and install additional hardware.

Contact a qualified carpenter.

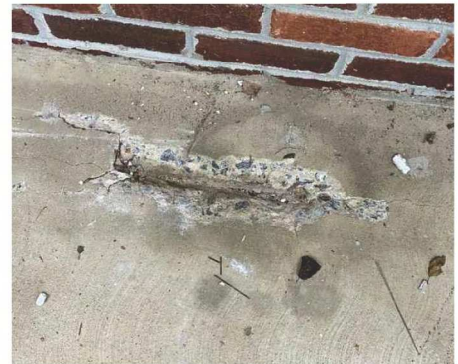
Front Porch Floor

PORCH CONCRETE FLOOR SPALLING

An area of concrete has popped off the finished floor to exposed oxidized reinforcement bar. A concrete patch is recommended to prevent further damage.

Contact a handyman or DIY project

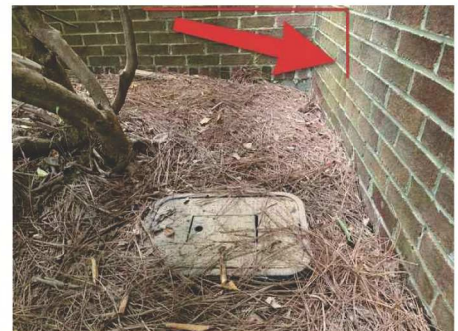
Front Elevation Right Side

NEGATIVE GRADING

Grading is sloping towards the home in some areas. This could lead to water intrusion and foundation issues. Recommend qualified landscaper or foundation contractor regrade so water flows away from home.

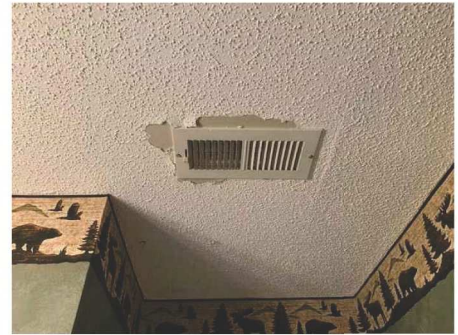
Second Floor Front Bedroom

Paint is peeling from the finished surfaces adjacent to the HVAC vent. This may be an indication of moisture issues with the HVAC system. Differentials in moisture content and temperature between the finish surface and the insulated duct work can cause flaking paint or the growth of biological organisms. A qualified HVAC Contractor should evaluate the ability of the unit to condition the air for proper humidity.

Contact a qualified heating and cooling contractor

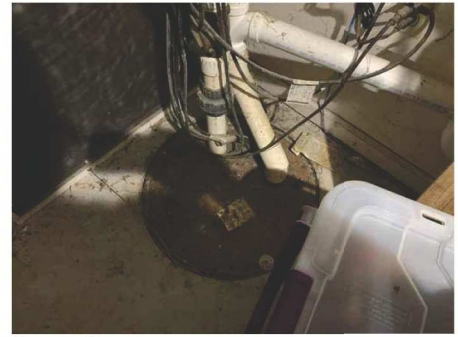
Sump Pump

The sump pump collection reservoir is located in the basement utility room off of the garage. The pump was plumbed with rigid connections making it difficult to inspect without removal of plumbing. Recommend monitoring function of pump due to inaccessibility.

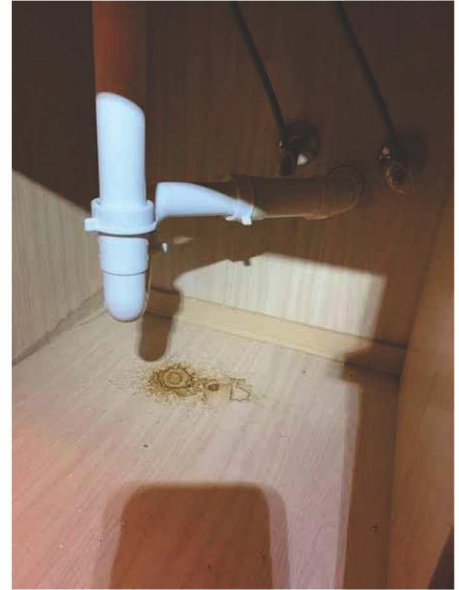
Basement Wet Bar Room Sink Cabinet

SINK - SIGNS OF PAST PLUMBING LEAKS

An active leak was not present at the time of inspection, however several stains in the floor of the base cabinet indicate past leaks. Recommend monitoring this location and have a qualified plumbing contractor evaluate.

Contact a qualified plumbing contractor.

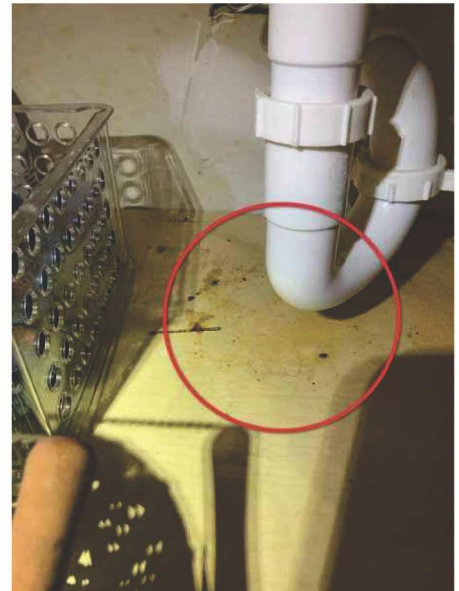
Under Sink At Basement Bathroom

SINK - SIGNS OF ACTIVE LEAK

Water pooling under the P-Trap was observed with past stains. Recommend a qualified plumbing contractor repair.

Contact a qualified plumbing contractor.

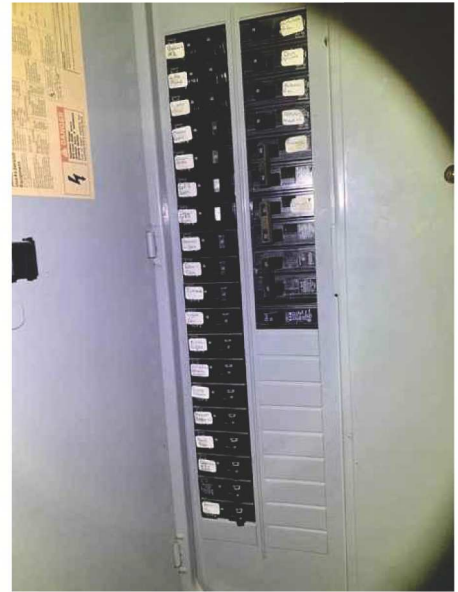
Breaker Panel At Garage

MISSING LABELS ON PANEL

At the time of inspection, some breakers in the main panel were missing labeling. Recommend a qualified electrician or person identify and map out locations.
